# Manhole Inspection Summary

Manhole # S150\_\_001MH

Insp Date: **3/27/08 12:53 PM**

**Location** Address: **2680 DULANY-LEHMAN** Cross Street: **EAST LYNNE AV**

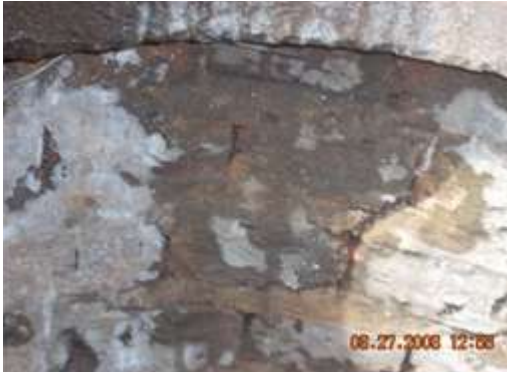
Defect 4

Infiltration: ☐ None ☒ **Joint** ☐ Cracks ☐ Mortar ☐ Roots ☐ Wall

CORBEL INFILTRATION

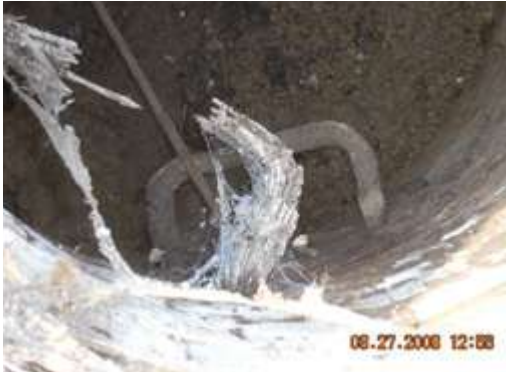
Defect 3

**Steps** Count: **1** Missing: **1** ☒ **Corroded**

MISSING AND CORRODED STEPS

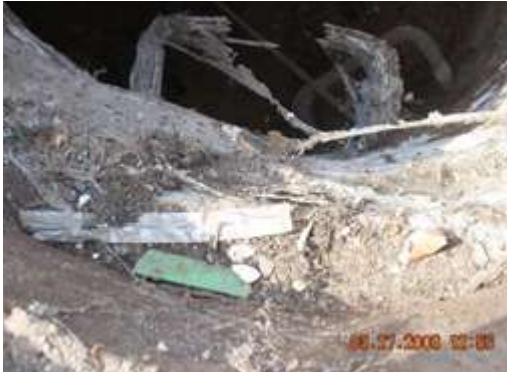
Defect 2

**Frame** Offset: **4** (in.) Condition: ☒ Sound ☐ Cracked ☐ Leaks

FRAME OFFSET

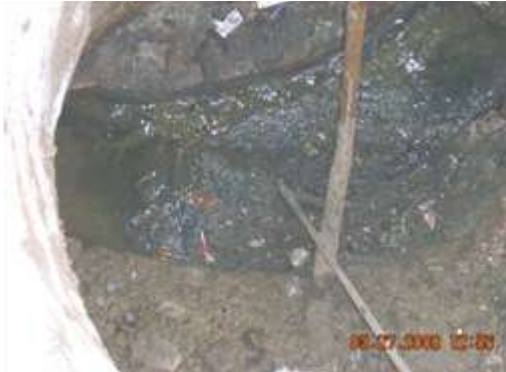
Defect 1

Condition: ☐ Sound ☐ Cracked ☐ Root Intrusion ☐ Deteriorated ☐ Leaks ☒ **Debris**

DEBRIS IN CHANNEL

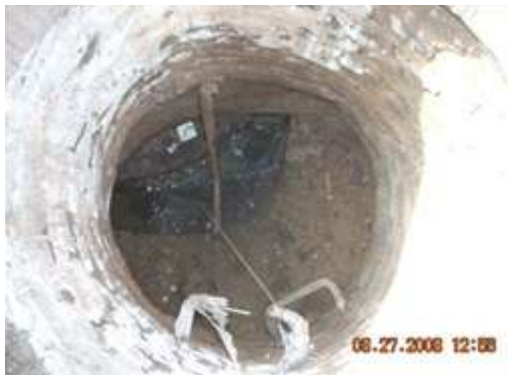
### Defect 5

Condition: ☐ Sound ☐ Cracked ☐ Root Intrusion ☐ Deteriorated ☐ Leaks ☒ **Debris**

bench cond debris

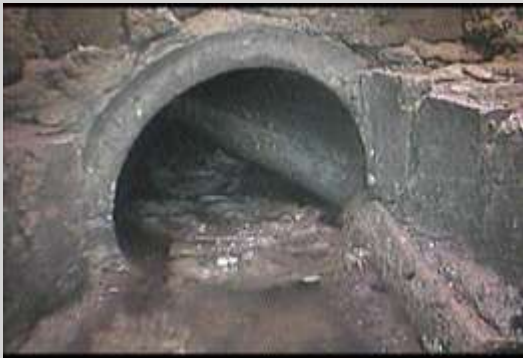
12 O'Clock Outflow

Pipe Height: **8.4** (in.) Rod and Bar (Angled)  
Pipe Material: **Clay** ☐ Pipe Lined  
Invert Depth: **7.15** (ft.) Flow Characteristics: **Slow**  
Deposits: ☐ None ☐ Mud ☒ **Sludge** ☐ **Debris** ☐ Grease  
Silt Depth: **3** (in.) Deposits Extent: **Light**  
Infiltration: **None** Pipe Seal Cond: **Sound**

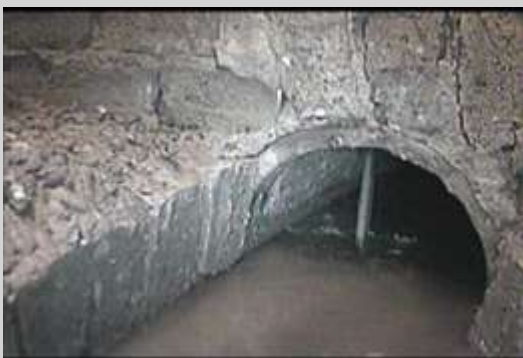
9 O'Clock Inflow

Pipe Height: **8.4** (in.) Rod and Bar (Angled)  
Pipe Material: **Clay** ☐ Pipe Lined  
Invert Depth: **7.08** (ft.) Flow Characteristics: **Slow**  
Deposits: ☐ None ☐ Mud ☐ Sludge ☒ **Debris** ☐ Grease  
Silt Depth: **3** (in.) Deposits Extent: **Medium**  
Infiltration: **None** Pipe Seal Cond: **Sound**
